ANGKOR VAT

INDIA'S CONTRIBUTION IN CONSERVATION

MEMOIRS OF THE
ARCHAEOLOGICAL SURVEY OF INDIA
NO. 91

B. NARASIMHAIAH

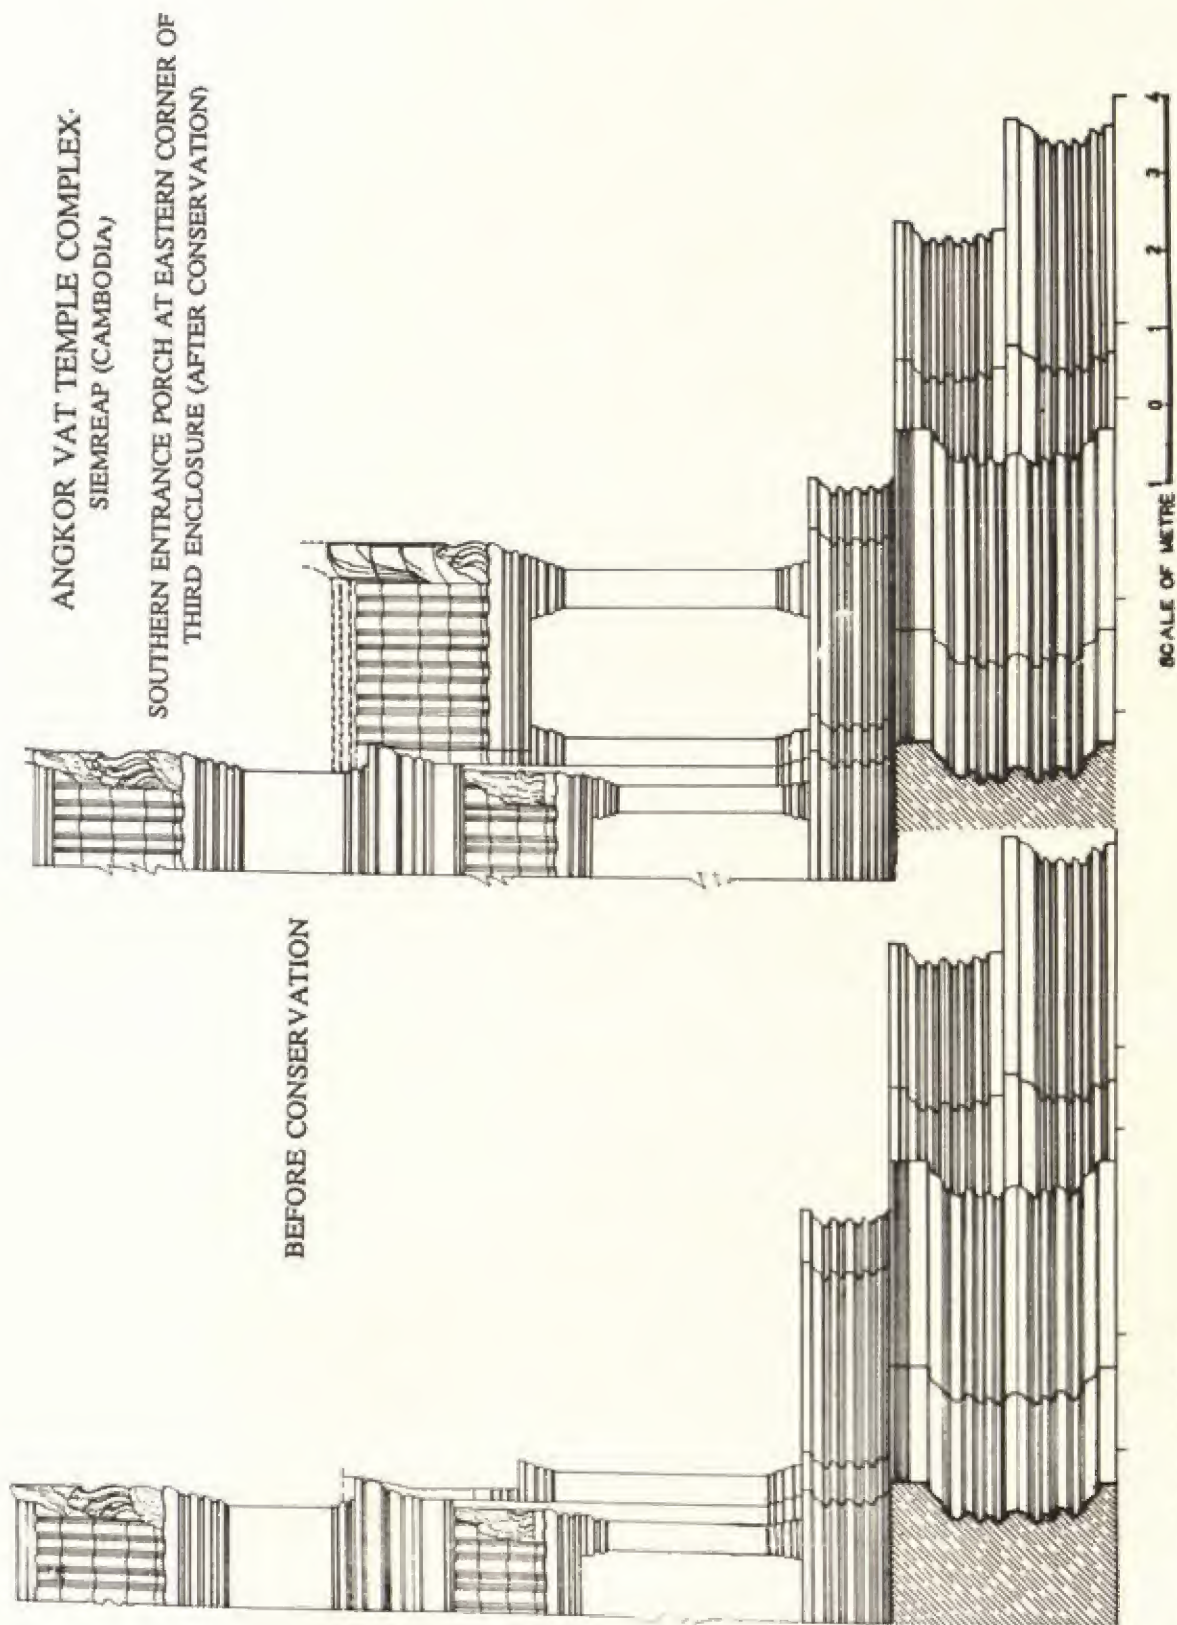
FIG. 4

This structure south of Samudramanthana gallery had also been completely dismantled by the French team before 1970, and constructed upto the plinth level as in the case of Samundramanthana gallery. Before taking up reconstruction work all the measurements of this structure, cruciform in plan were taken and marked on the plan where it had to be constructed. Care was obviously taken about the diagonal measurements. Meanwhile, the architectural members of this structure were identified. Then, the door frames were fixed in their original position. Thereafter, the whole structure was reconstructed by using more than six hundred and sixty-one (661) architectural members (pls. XXXII-XXXIII). At every stage all the measurements including diagonal ones and the levels as well as verticality were checked up. After reconstructing the whole structure was watertightened by grouting and pointing.

However, while reconstructing the structure, it was found that even big crane could not lift architectural members to the required height to restore top three courses. Therefore, a platform at the required height in scaffolding materials had to be constructed to take the stones from the crane, and then the stones had to be moved to their proper position over the wooden planks fixed on the scaffolding. This was a hazardous task as the architectural members were large in size and weighed between 800 and 2,000 kg.

Two (2) pillars including the mended one were erected in the proper position and after fixing the beams over them, the available roof members were placed (fig. 4). It was found that the majority of members were missing even before it was dismantled by the French team. However, in the process of reconstruction twenty-one (21) architectural members were used.

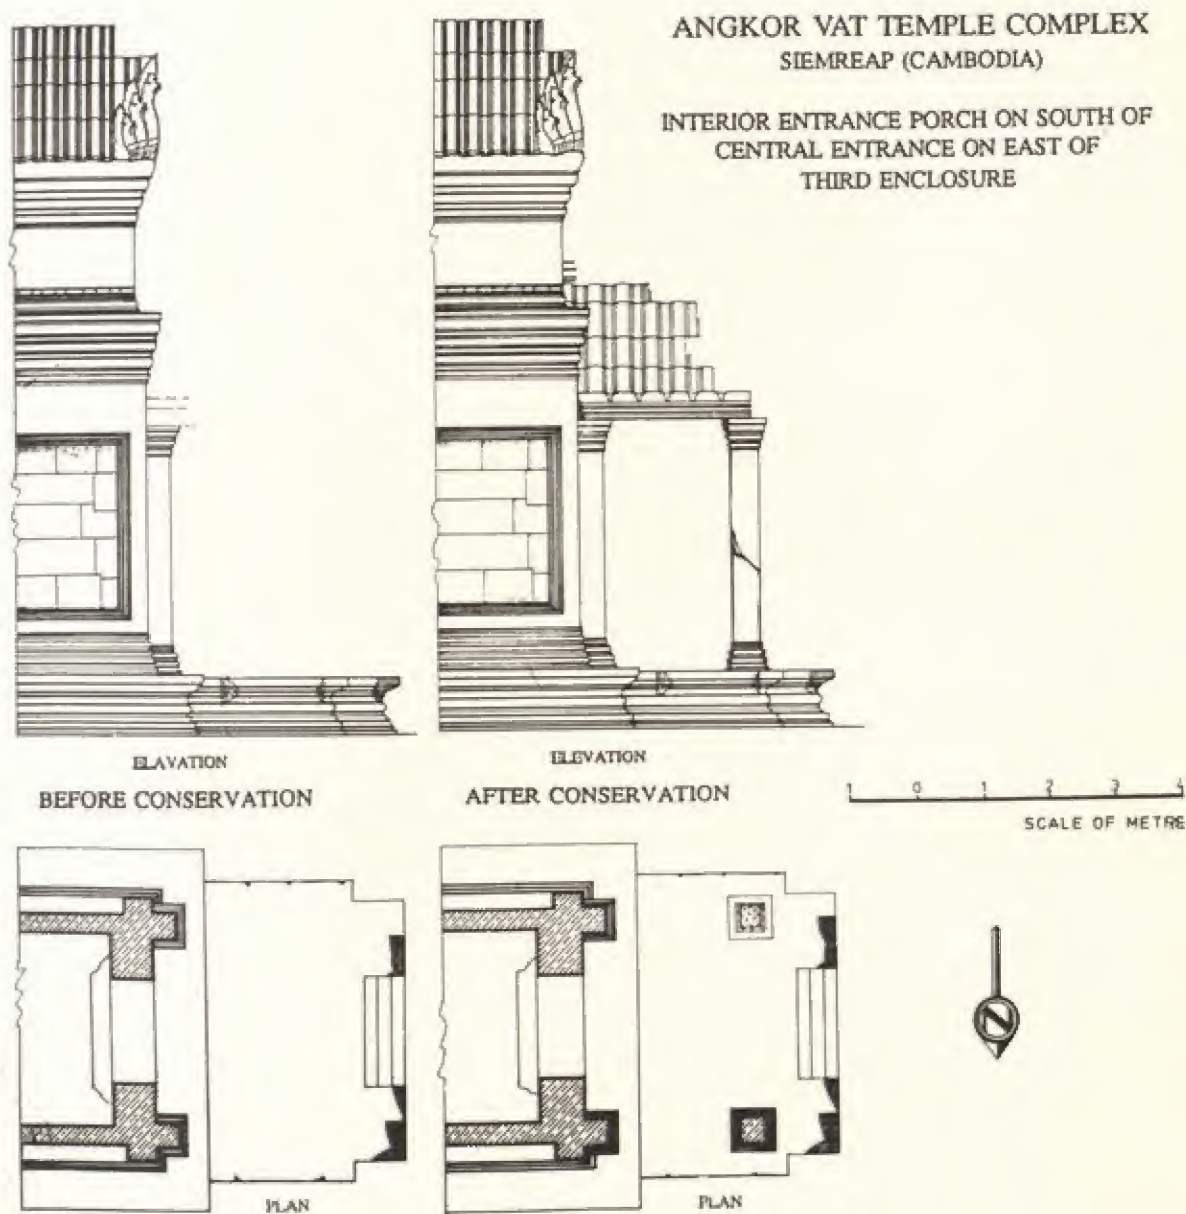
FIG. 7

It may be recalled here that the superstructure of this porch had been dismantled long ago, but one original pillar and an RCC column for the other pillar with two beams over them were standing. Even the original pillar had vertical cracks showing the tendency of flaking. In addition, the architectural members of the plinth and the flooring had been dislodged. Vegetation was growing profusely in the gaps of the masonry. Therefore, the dismantling of even the extant portion was unavoidable.

Before executing further reconstruction of the porch, the damaged pillar was suitably mended and strengthened by providing concealed steel rods and brackets. In the place of missing pillar, an RCC pillar was cast *in situ*. In addition, a beam which had broken into three pieces was mended and strengthened by providing concealed I-section girder. After placing the available two beams over the pillars, the vaulted roof was reconstructed by using fourteen (14) architectural members (refer pls. XXVIII-XXX). It may be remembered that many of the members including front beam and *torana* were missing even before it was dismantled (fig. 7). The structure was watertightened by grouting and pointing.

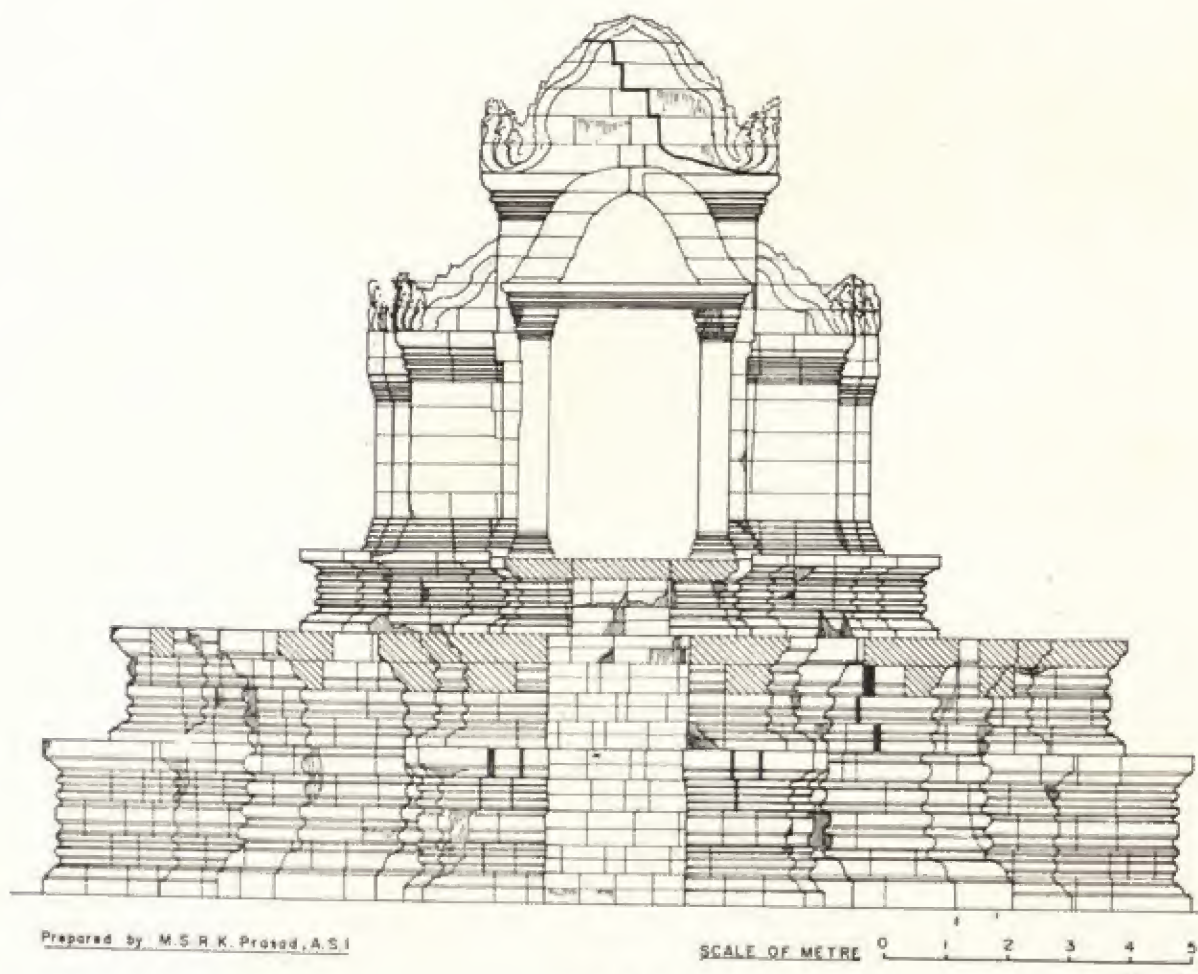
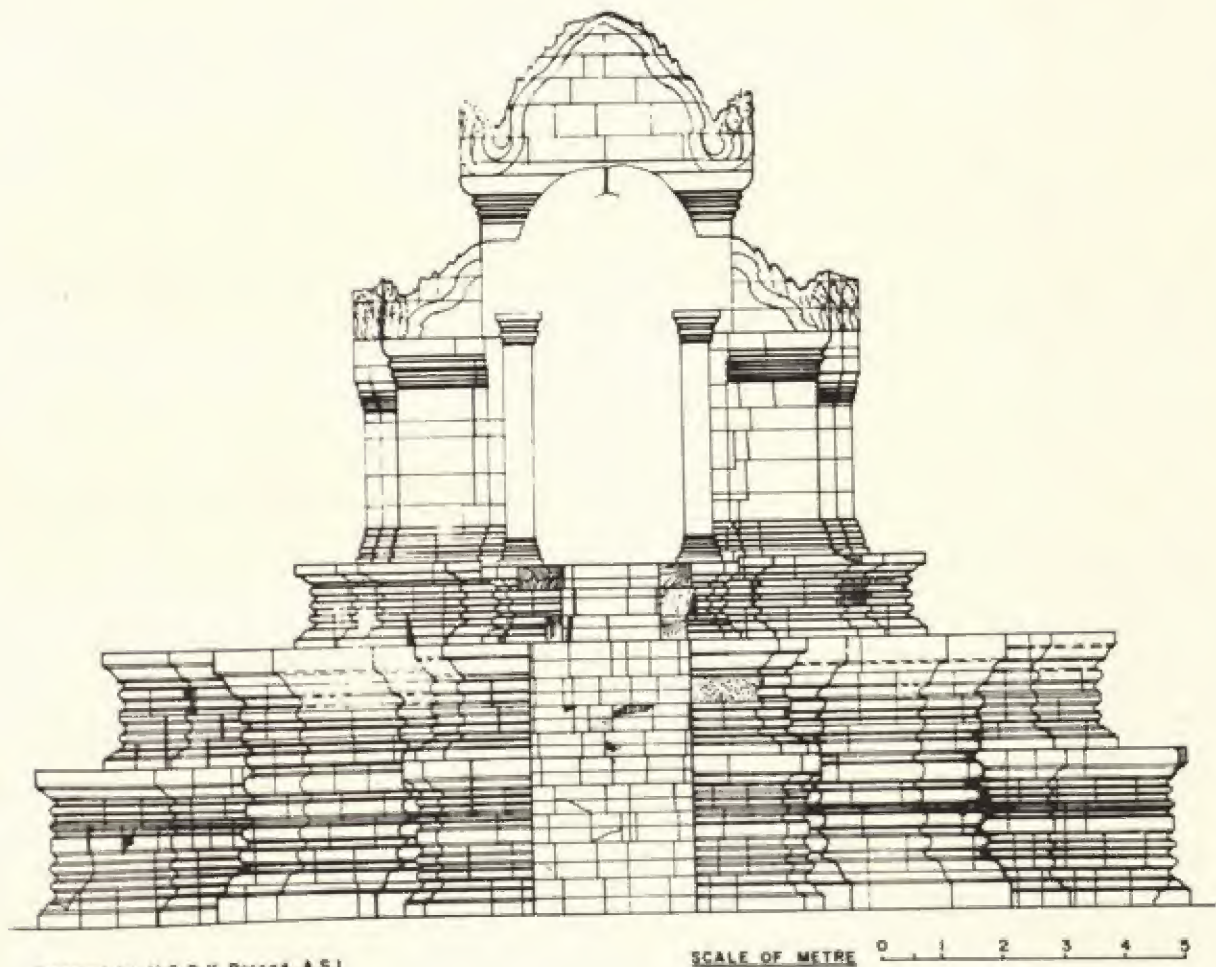
FIG. 11a

EASTERN FAÇADE—The façade (fig. 11) including plinth and stepped entrance flanked by massive balustrades was in dilapidated condition due to horizontal dislodgment of architectural members. The dislodgement of members was so severe in some portions due to heavy growth of vegetation that such portions had to be dismantled and reconstructed as per the original after consolidation of the core which had also suffered damages. In the areas where the dislodgement was not so pronounced, the displaced architectural members were pushed back to their original positions with the help of horizontal jacks and by human efforts (pl. XLIX). While conserving this façade, thirty-six (36) architectural members were dismantled and reset and another nine (9) members were reset without dismantling.

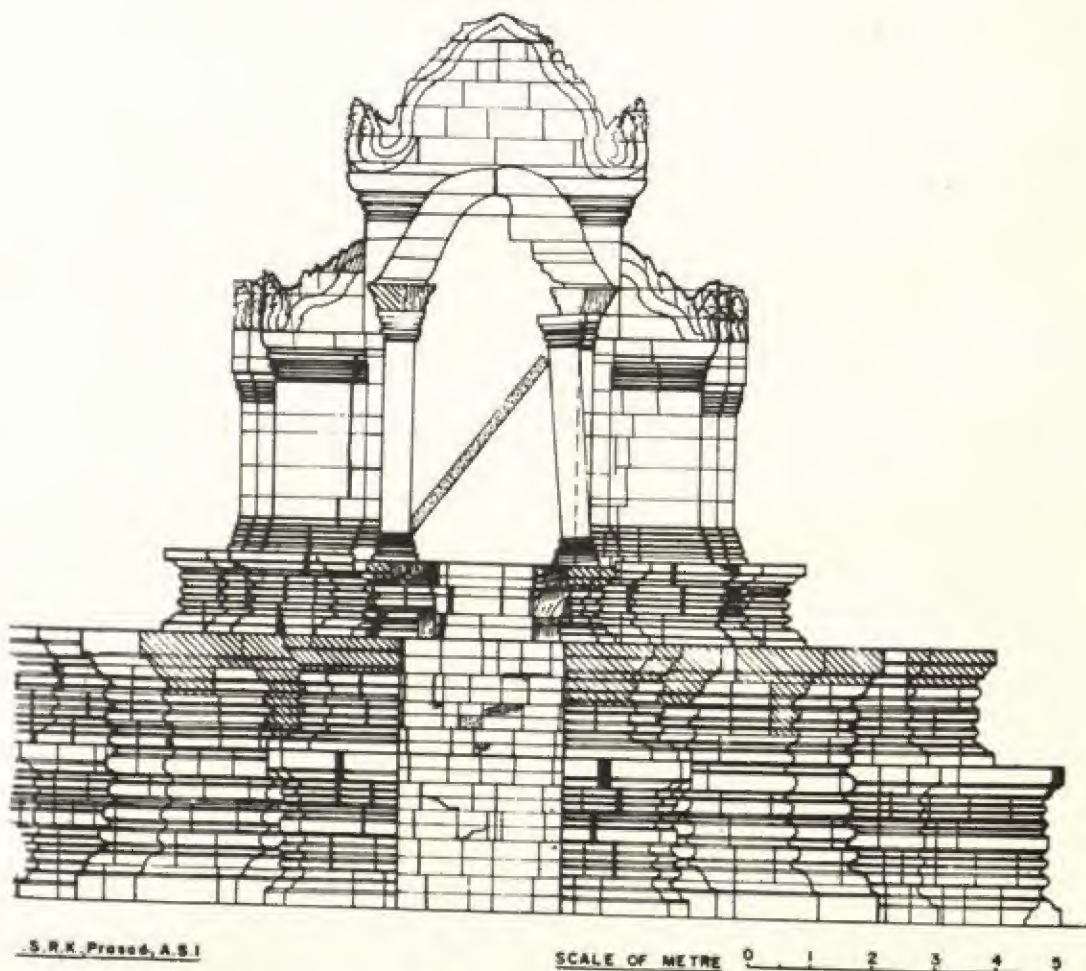
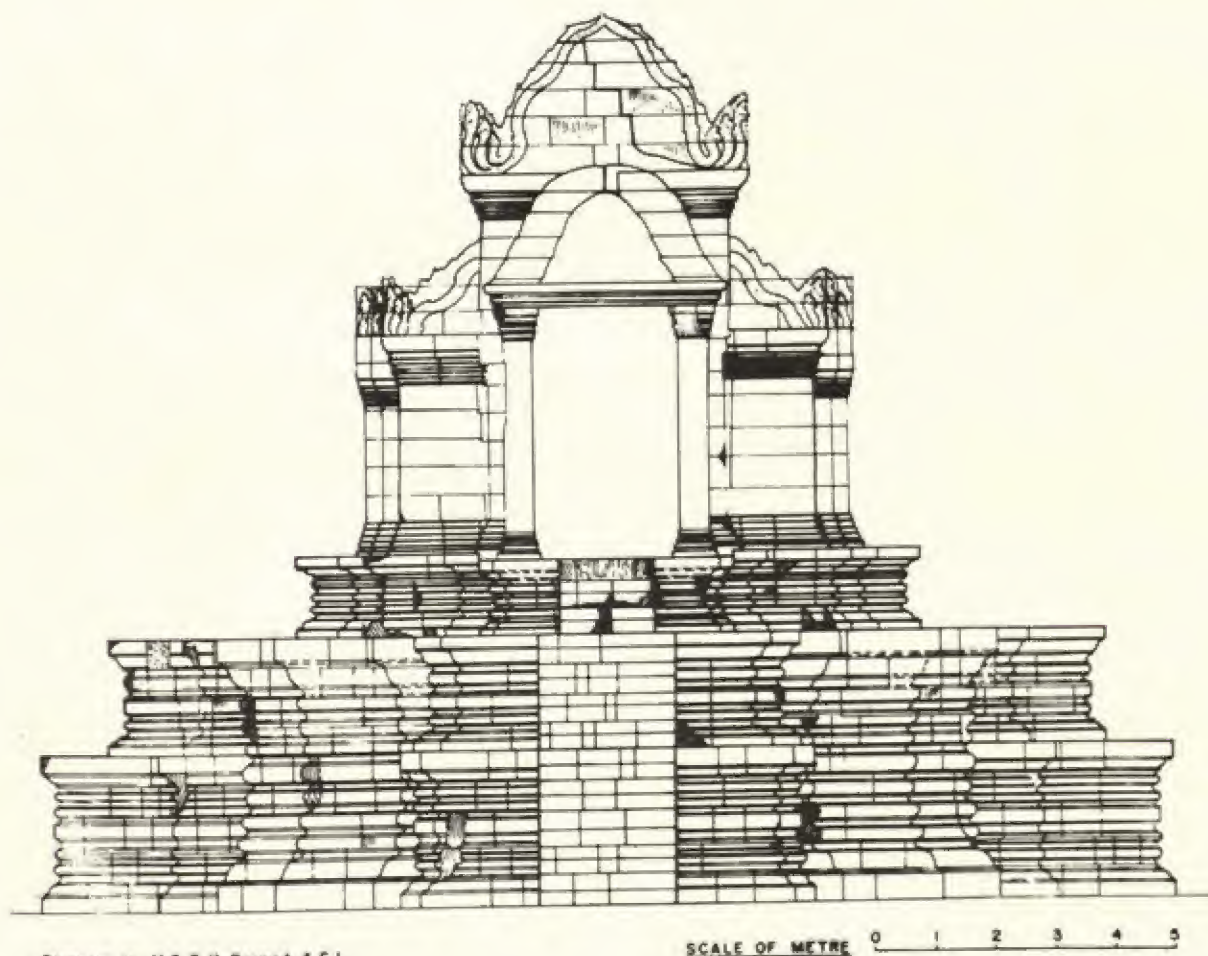
Fig. 12a

WESTERN FAÇADE—The whole of western façade (fig. 12) including massive double plinth stepped entrance flanked by balustrades and landings, entrance porch and topmost *torana* was in dilapidated condition. Therefore, the conservation work had to be carried out with great care on priority basis in a phased manner.

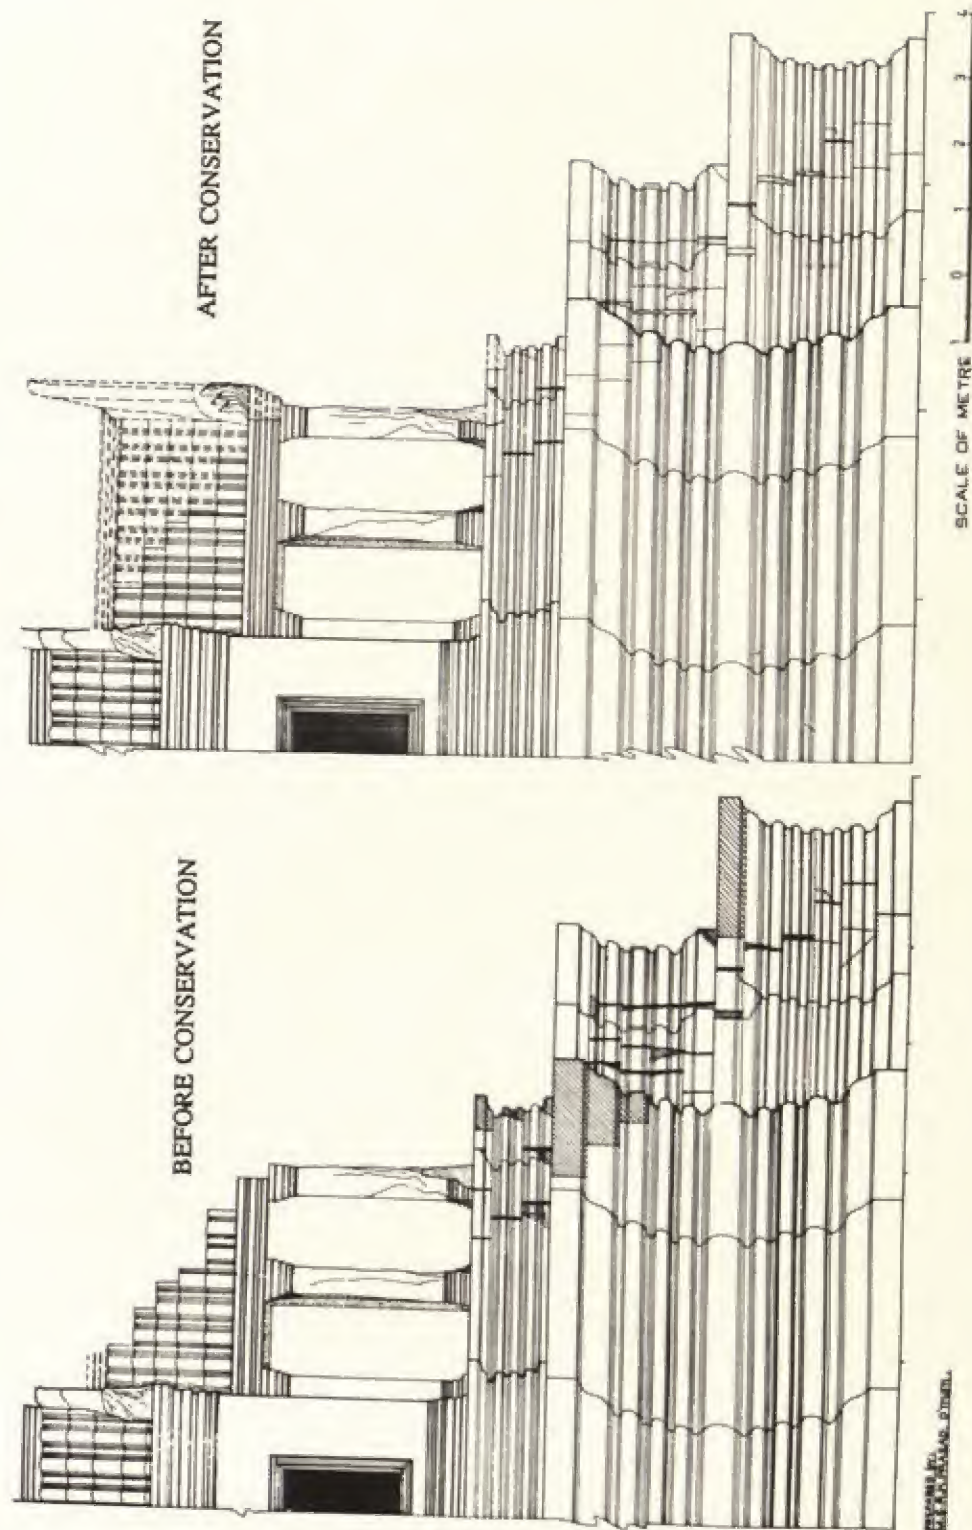
Fig. 16

This entrance, similar in construction had same conservation problem as that of the above

mentioned one. All the dislodged twenty-one (21) stone members were moved into their proper positions by using horizontal jacks and by human efforts. Another nine (9) members which had fallen down from their original positions were hauled up and fixed in their positions (pl. LV). The structure (fig. 16) was watertightened by filling up the gaps and crevices and grouting and pointing of the joints in the masonry.

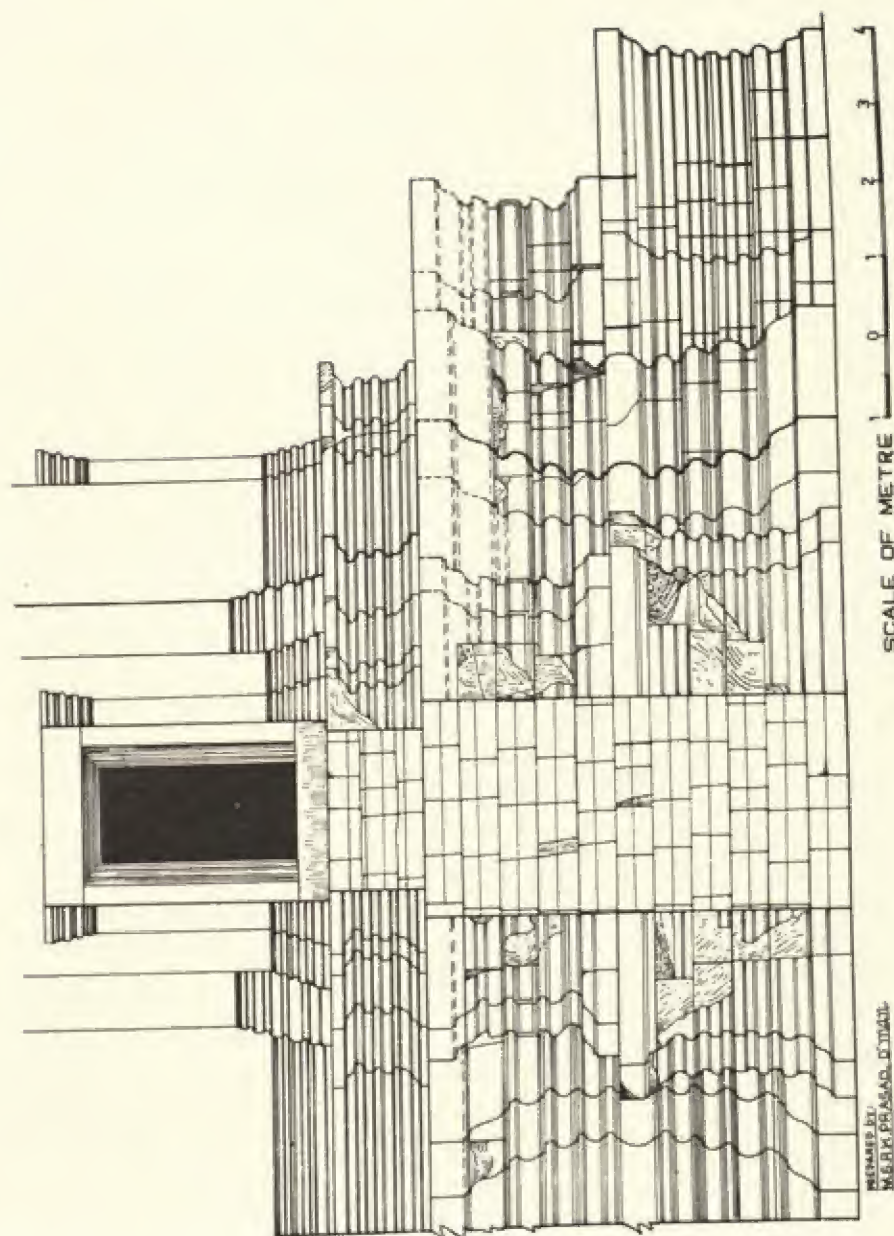
Fig. 17b

As in the case of other entrances of this enclosure, this one had also suffered very heavily due to vegetational growth. However, in this case, it was not possible to reset the dislodged stone members without dismantling, as the dislodgement was very severe. Therefore, some of the portions of the balustrades were dismantled and reset. Thirty-seven (37) architectural members were dismantled and reset, and another, thirty-eight (38) members which had been displaced were pushed back to their original position. In addition, two members, weighing nearly four tonnes each were hoisted back to their original positions in the balustrades (pl. LVI). The structure thus conserved was watertightened by grouting and pointing (fig. 17).

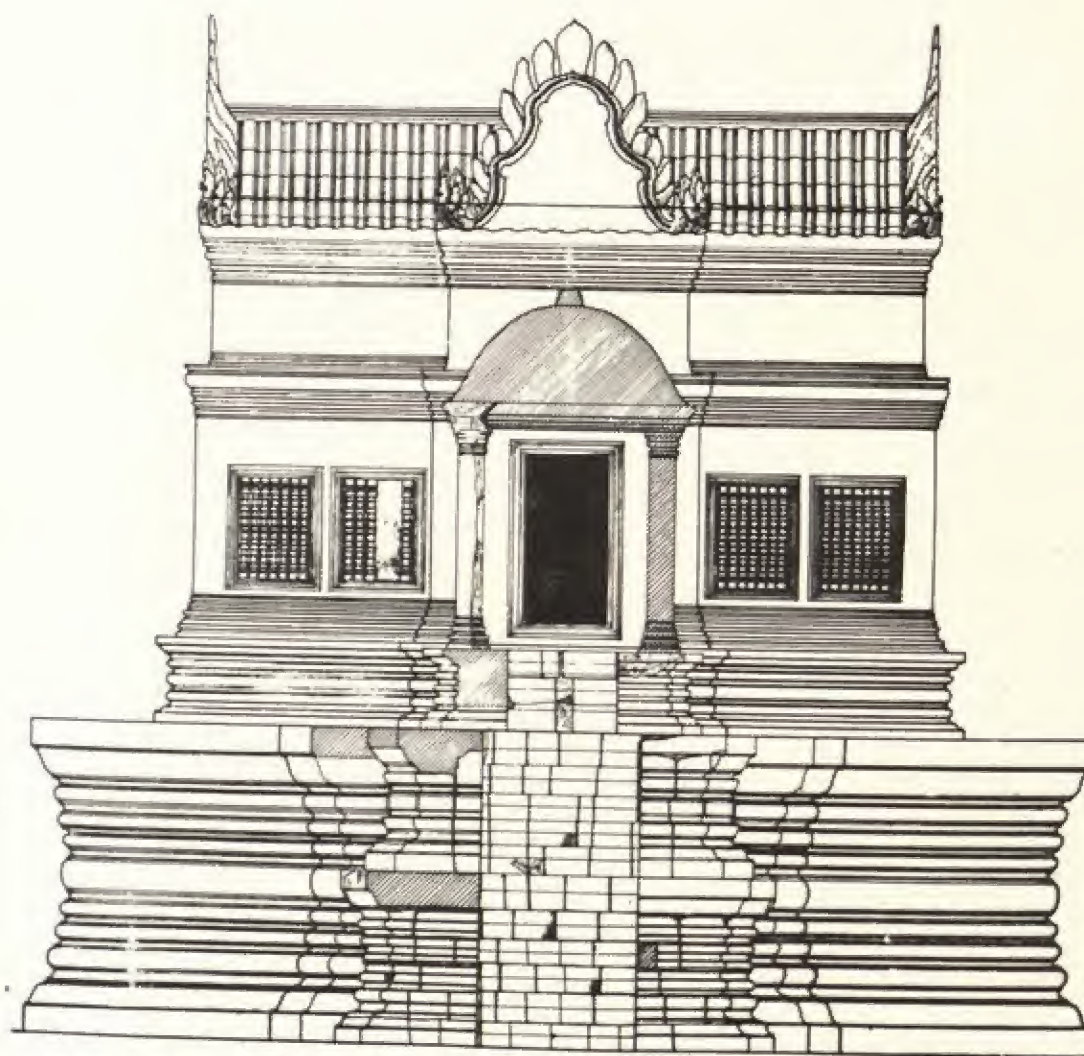
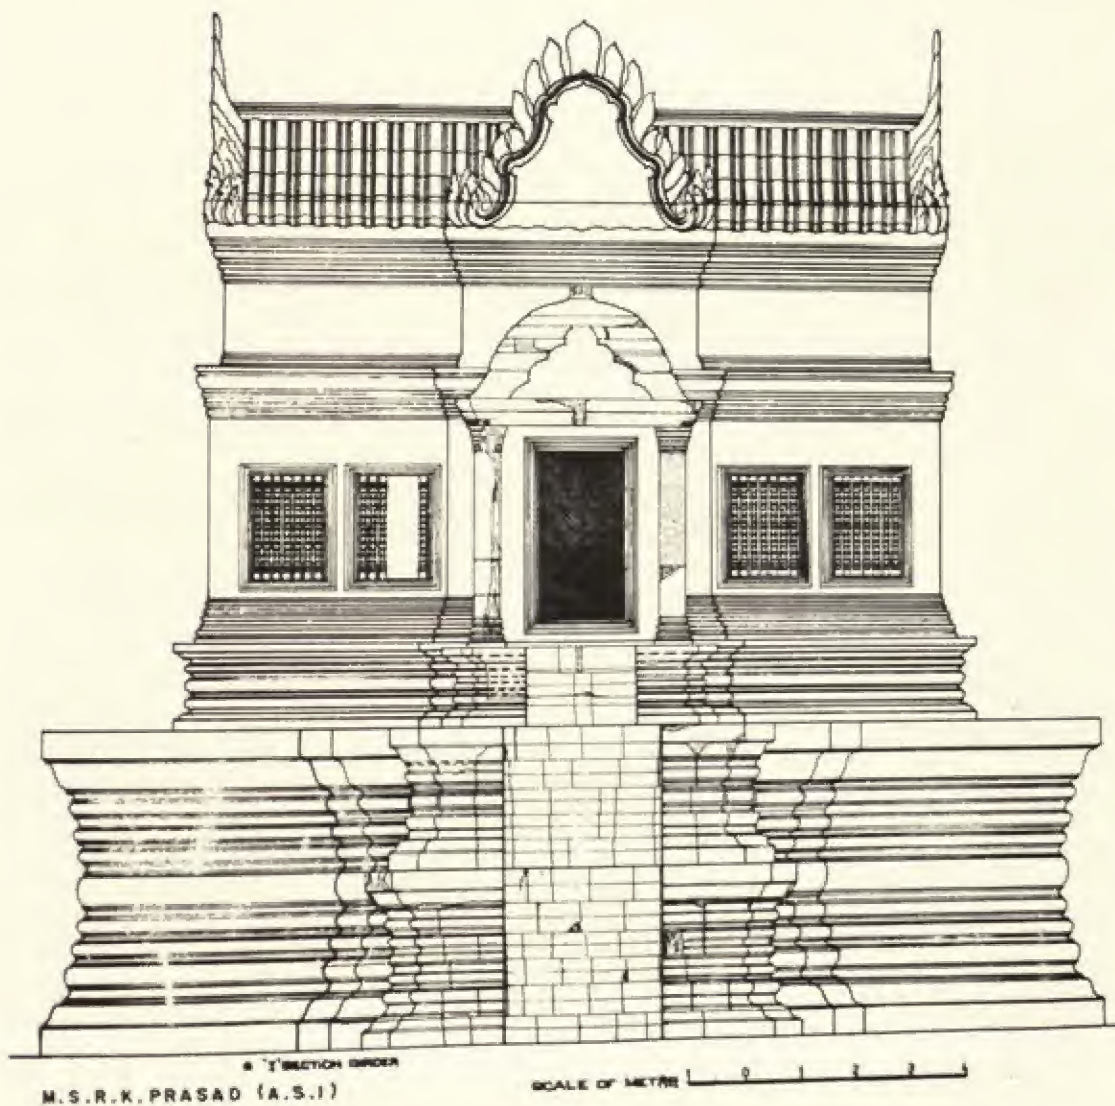
FIG. 18a

The flight of steps flanked by massive balustrades of this entrance also had the same conservation problems as those of the above mentioned one. The structure was conserved (fig. 18) in all respect including resetting of the dislodged members, lifting and fixing of the fallen members, grouting and pointing. Altogether, sixteen (16) members were reset in their proper position.

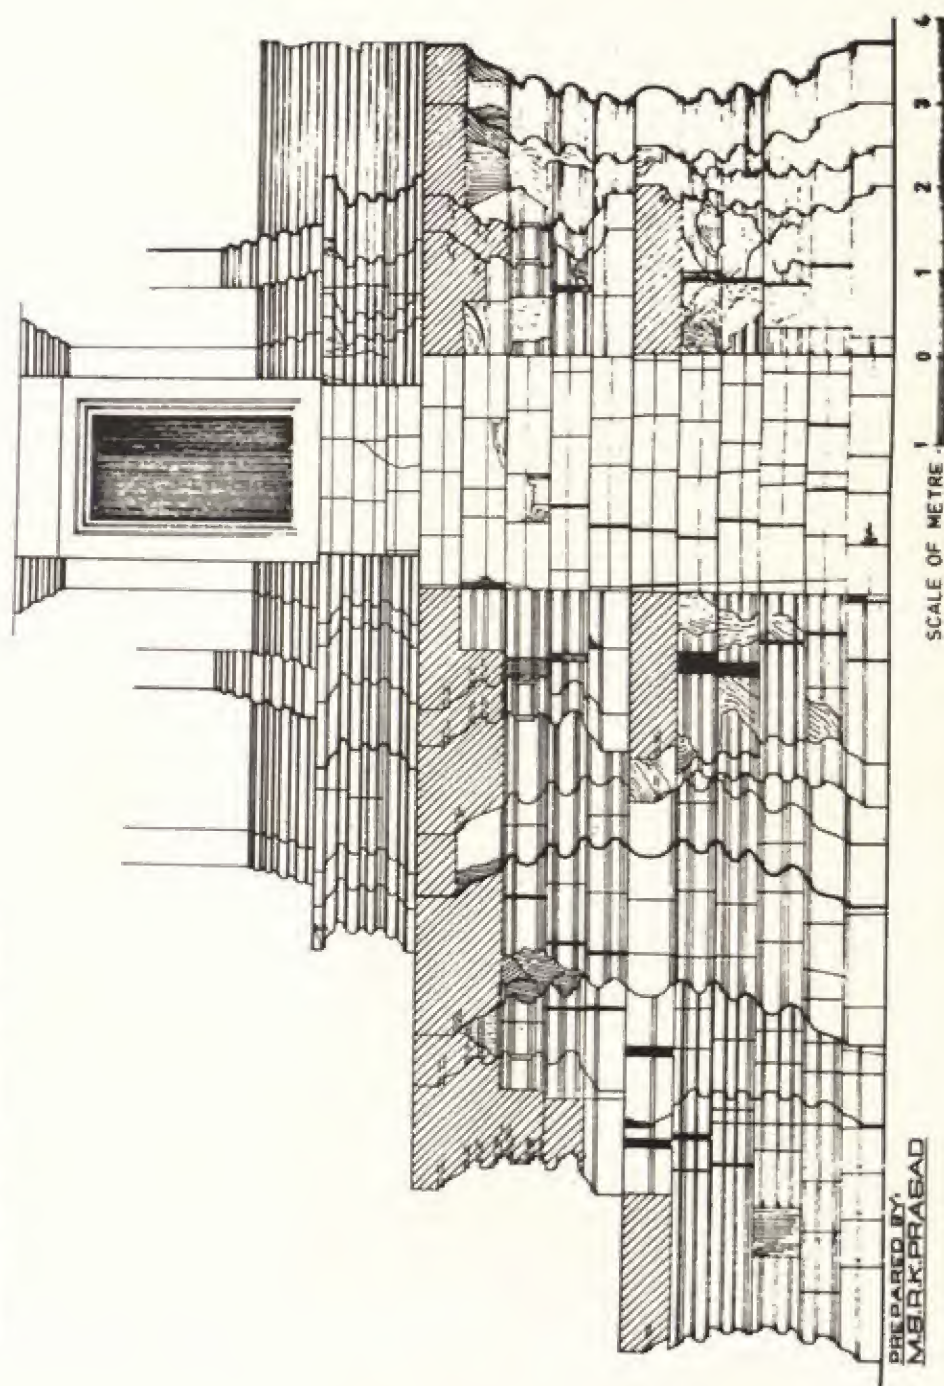
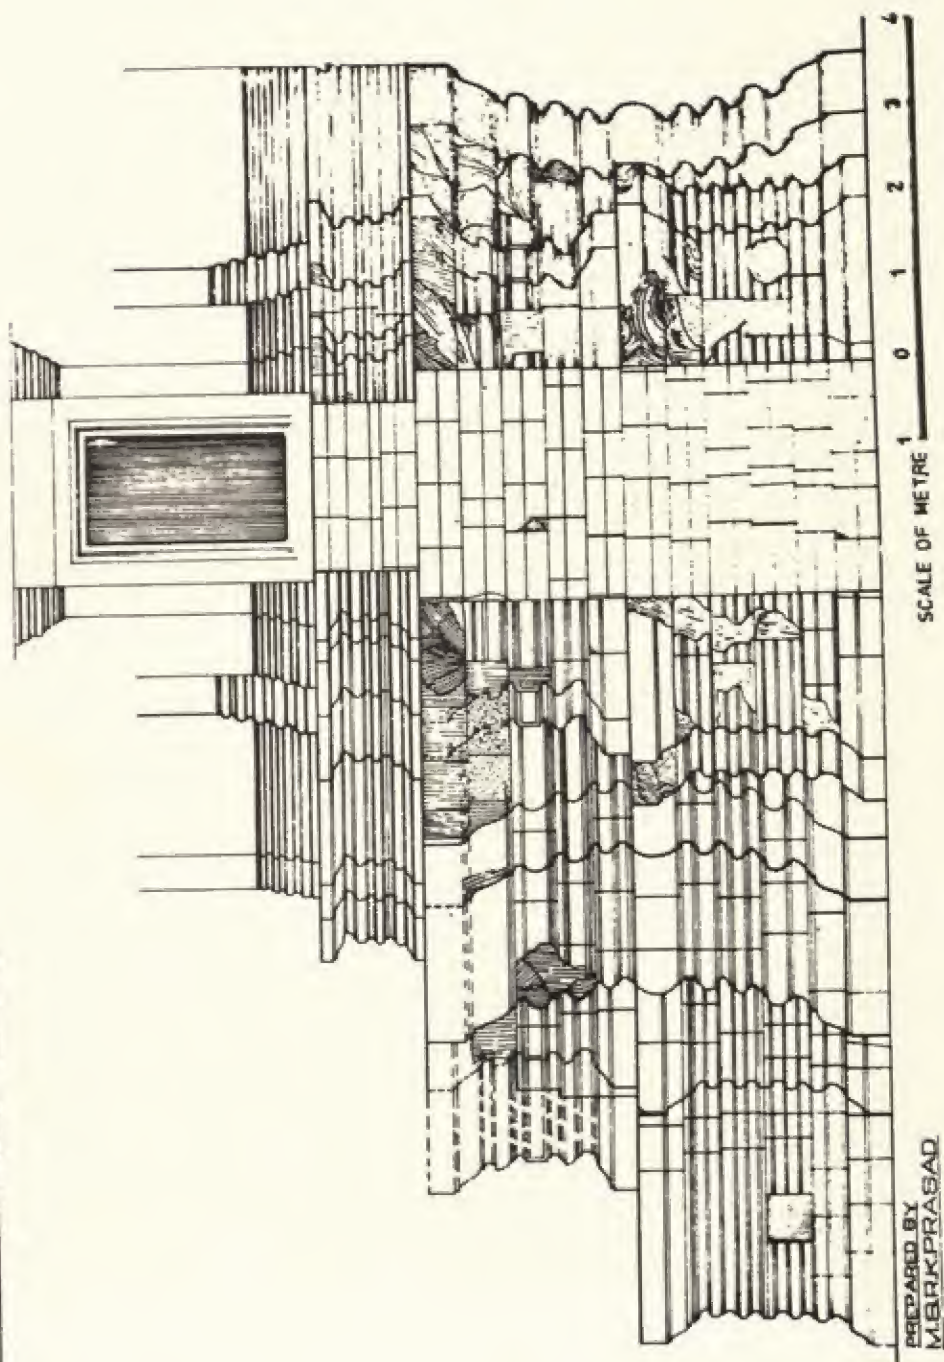
FIG. 20 a

WESTERN STEPPED ENTRANCE — This massive structure had suffered due to thick growth of vegetation and dislodgement of architectural members. Some of the portions had to be dismantled and reset after removing the deep rooted vegetation and consolidating the core. While conserving sixty-five (65) members of the plinth, balustrades and steps were dismantled and reset. In addition, two (2) stones of balustrades weighing nearly four tonnes each which had fallen down were hauled up and fixed in their original positions in the structure (pl. LX). Then the whole structure (fig. 20) was watertightened.

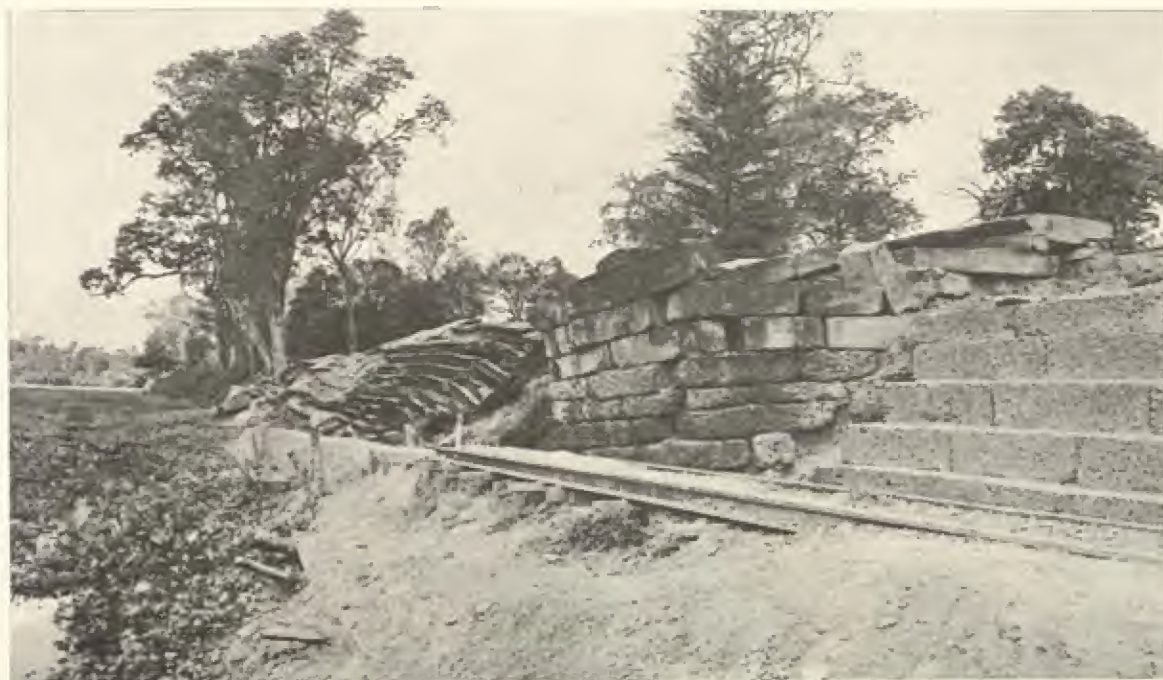
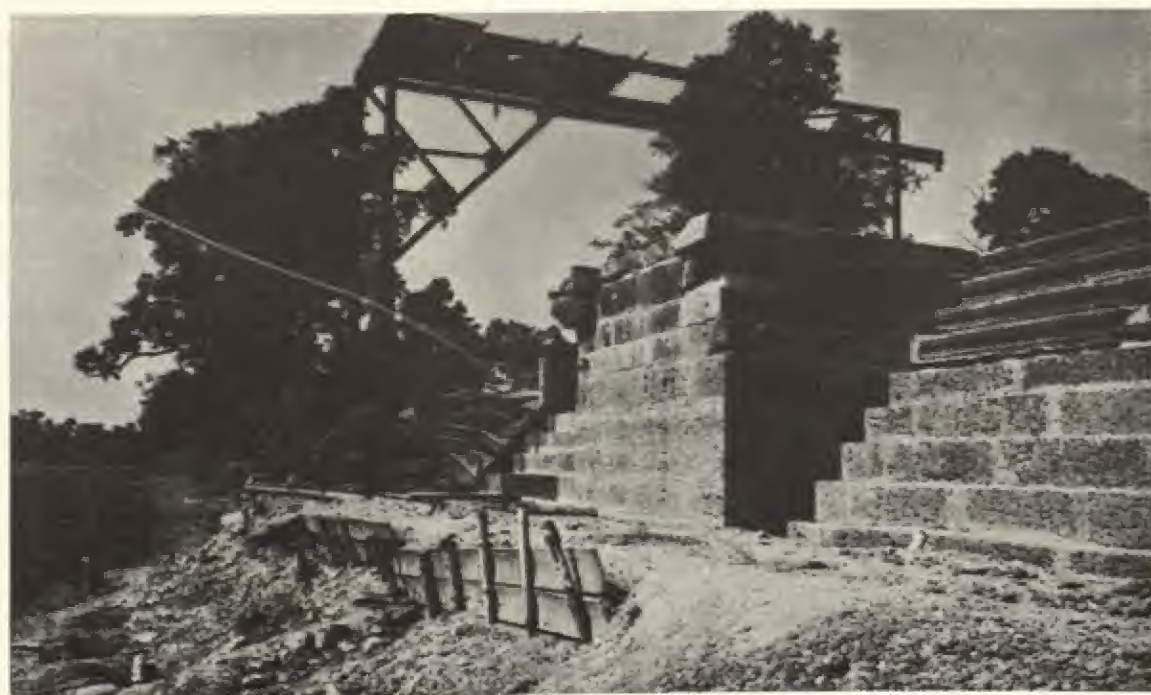
Stepped embankment of moat: A, before and B, after conservation

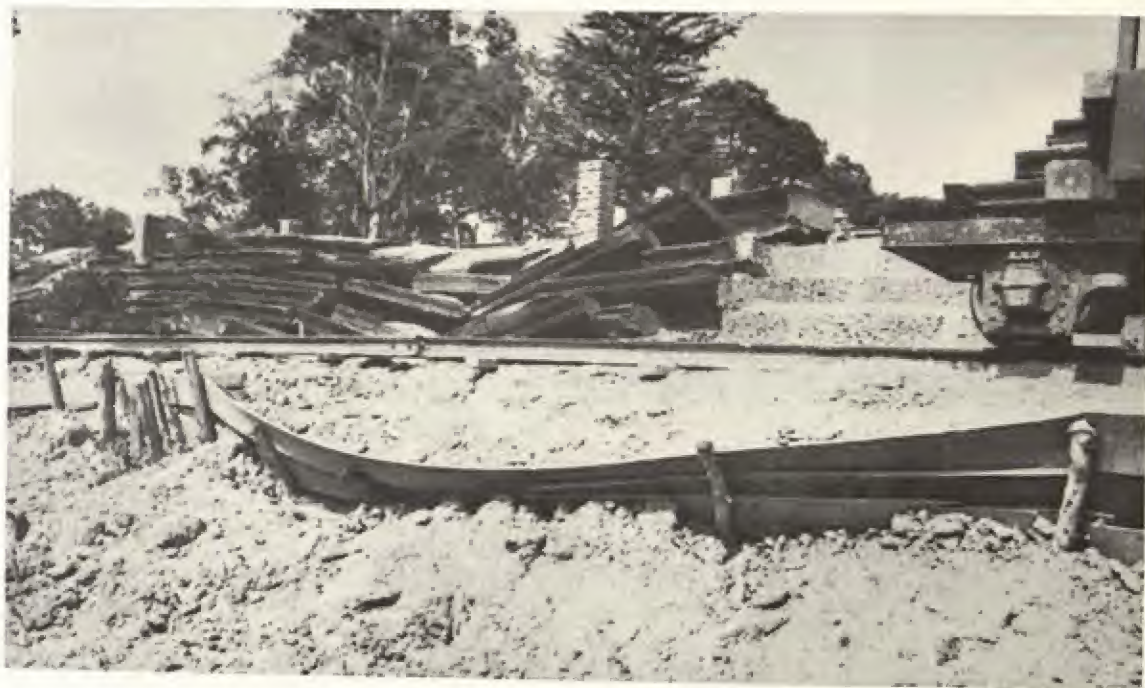
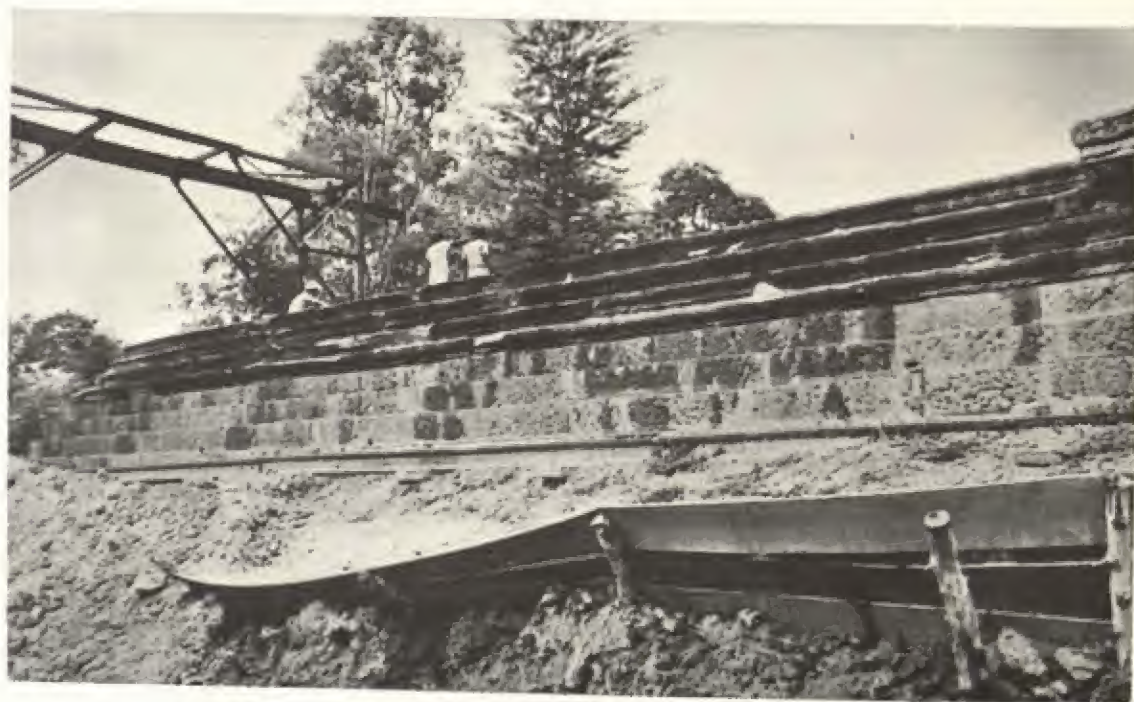
Stepped embankment of moat : A, before and B, after conservation

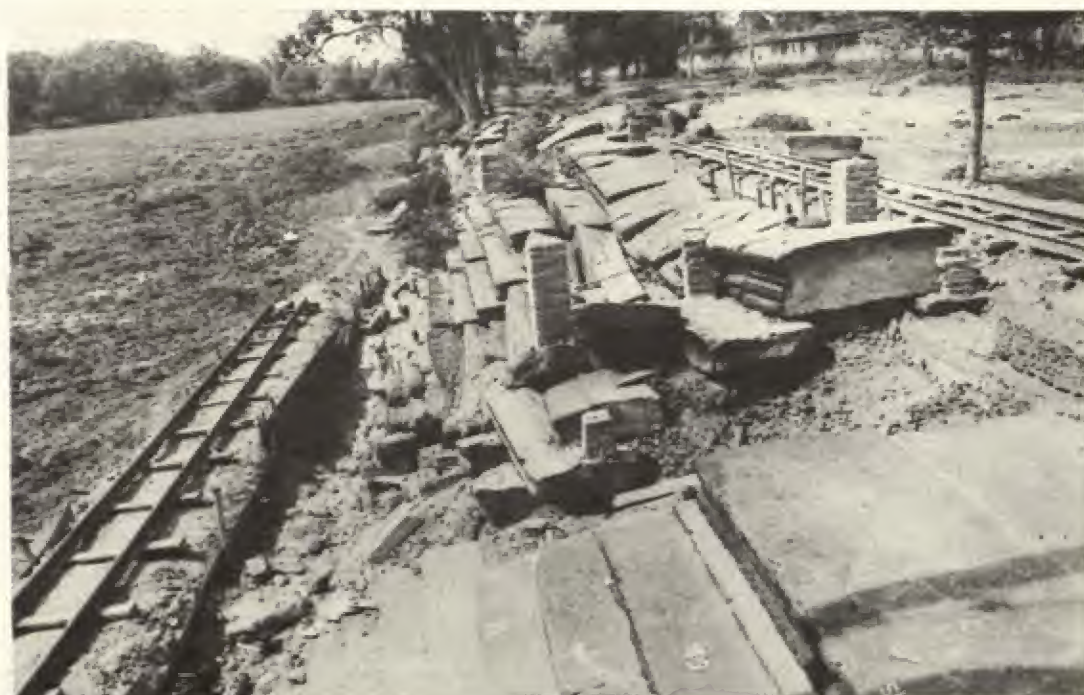
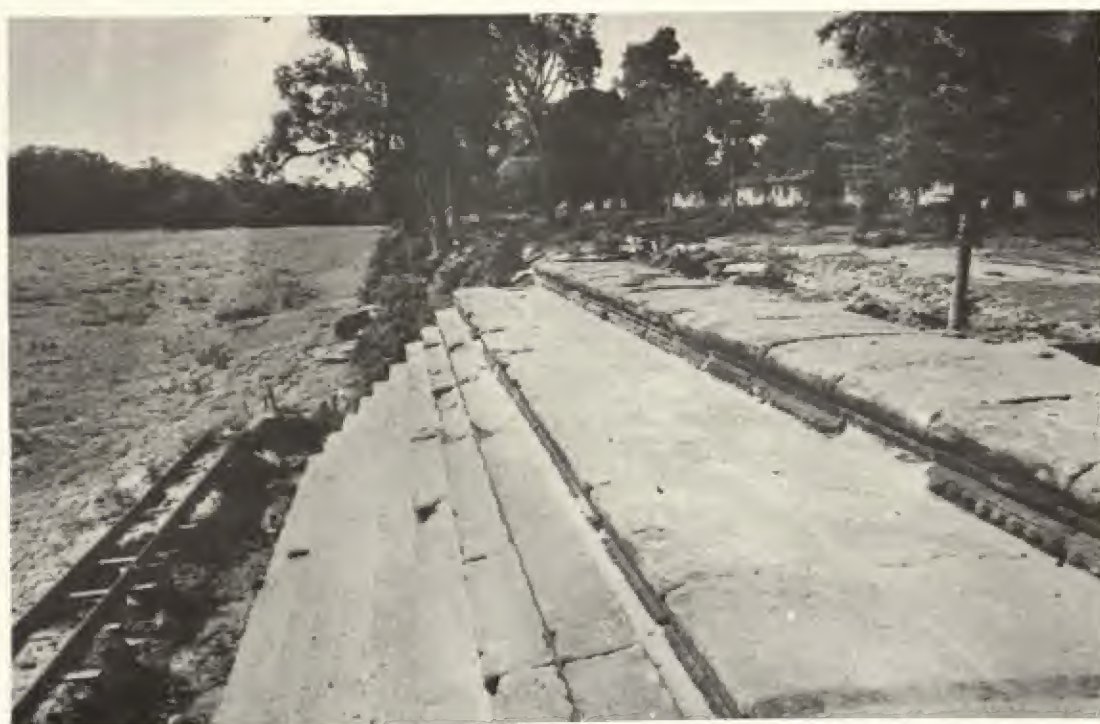
Stepped embankment of moat : A, before and B, after conservation
